**FAILURE ANALYSIS OF REINFORCED CONCRETE CROSSARMS IN OVERHEAD  
 DISTRIBUTION LINES: A CASE STUDY**

Elger Dias Reis<sup>1</sup>, Aysser Saliba Monteiro Laizo<sup>2</sup>, Elvys Dias Reis<sup>3</sup>

### CASE STUDY

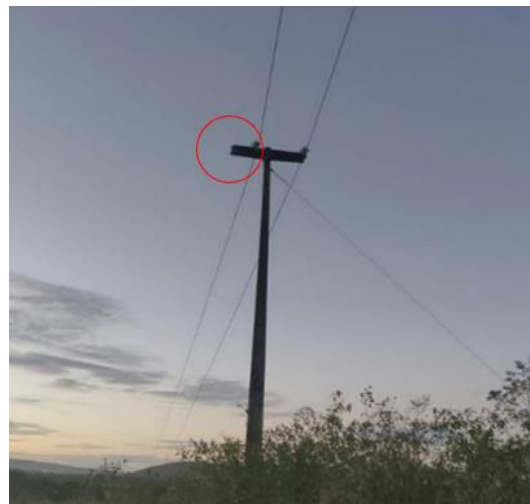
In February 2022, within the city of União dos Palmares, Alagoas, Brazil, a crossarm supporting the three cables of the system ruptured at the structure located at coordinates 9°07'24.4"S and 36°02'33.0"W, resulting in a complete power outage for the entire city. Figure 2 depicts the type of suspension structure and highlights the specific point of crossarm failure.

Figure 2 – Suspension structure with broken crossarm.

Figure 2 illustrates a cable-stayed pole structure with cables present on one side only. As the transmission line changes direction, there is an angular deviation between the underlying spans. In the studied stretch, the subjacent spans of 207 and 91 meters form a 5° angle. Although minor, this directional deviation causes resultant forces to pull the suspension structure towards the formed side, necessitating the installation of tension rods on the opposite side to maintain mechanical balance.

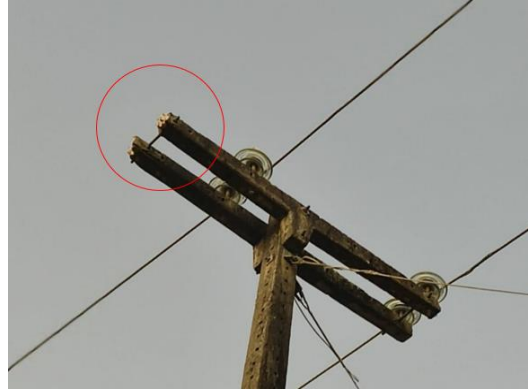
Figure 3, in turn, emphasizes the type of crossarm utilized in the system and precisely locates the point of material failure, which occurred at the bearing point of an end cable.

Figure 3 – Broken crossarm at the bearing point of an end cable.

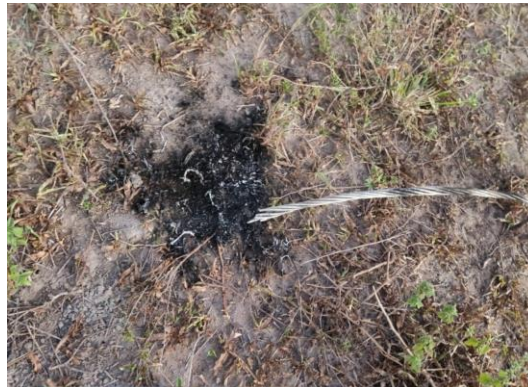
Initially, cable breakage was considered the primary cause of the incident. However, upon on-site inspection, it was discovered that the cables only broke after making contact with the ground due to the formation of arcing, as depicted in Figures 4 and 5.

Figure 4 – Evidence of the arc formed when the cable touched the ground.

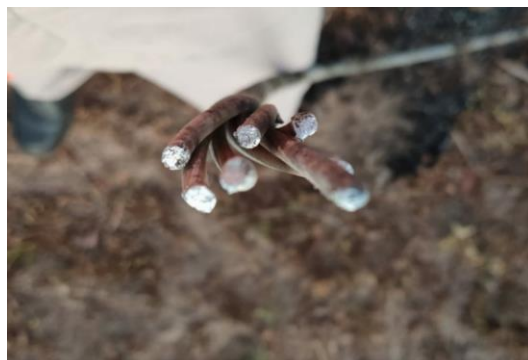
Figure 5 – Broken aluminum conductor wire.

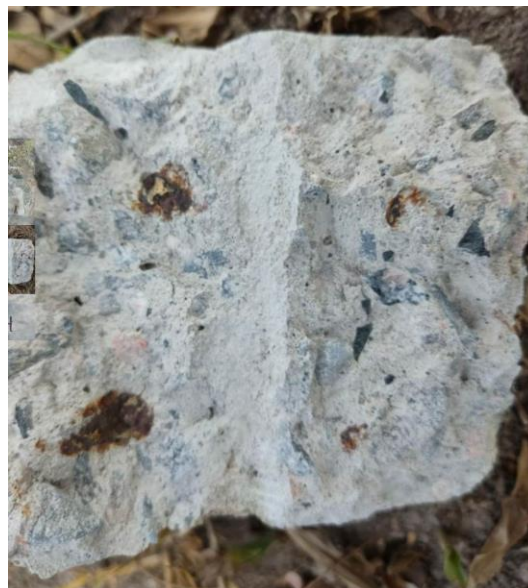
Figure 5 – Broken aluminum conductor wire.

Based on this evidence, it was determined that the accident resulted from the rupture of the reinforced concrete crossarm, as seen in Figure 7, which displays samples of the fractured crossarm. Figure 6, in turn, reveals that the concrete aggregate mixture is well-dispersed around the steel reinforcement bars and that there is no accumulation of dirt or organic matter on the inner surface of the component, indicating the sudden rupture of the crossarm. Additionally, it highlights the preferred failure direction, associated with shear in the gravitational direction. It appears that the steel reinforcement was not adequately designed, as one of the four required steel bars for the crossarm is practically absent from the failure surface displayed in Figure 6 and also in Figure 7, which focuses on the broken crossarm end. However, it is evident that this was not the primary cause of the accident, as crossarms are typically designed to have a service life exceeding 30 years, suggesting that the rupture should have occurred earlier.

Further analysis of this situation reveals that the abrupt rupture of the crossarm was caused by concrete creep. Due to the system's nearly constant loads and stresses, gradual increases in permanent deformations occurred over time, even if these stresses were below the material's strength limit. In the case of concrete, these deformations manifest as micro-cracks that propagate towards the external surface, leading to the sudden rupture of this structural component.
