**FAILURE ANALYSIS OF REINFORCED CONCRETE CROSSARMS IN OVERHEAD
 DISTRIBUTION LINES: A CASE STUDY**

Elger Dias Reis¹, Aysser Saliba Monteiro Laizo², Elvys Dias Reis³

This study focused on a section of a distribution line in the primary network of Equatorial Energia, which authorized the reproduction of the following images and information, operating at a voltage level of 13.8 kV. The line consists of three bare aluminum wires with a steel core, specifically 4/0 AWG type, supported by reinforced concrete crossarms of the Normal type, as illustrated in Figure 1.

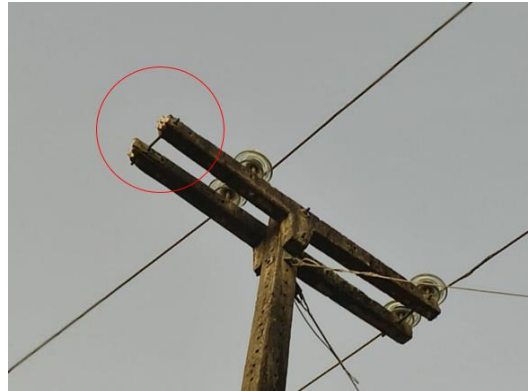
Figure 3, in turn, emphasizes the type of crossarm utilized in the system and precisely locates the point of material failure, which occurred at the bearing point of an end cable.

Figure 3 – Broken crossarm at the bearing point of an end cable.

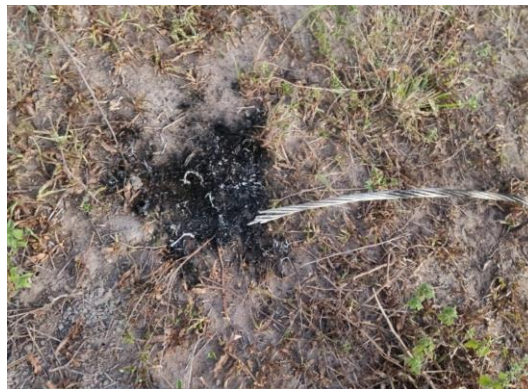
Initially, cable breakage was considered the primary cause of the incident. However, upon on-site inspection, it was discovered that the cables only broke after making contact with the ground due to the formation of arcing, as depicted in Figures 4 and 5.

Figure 4 – Evidence of the arc formed when the cable touched the ground.
