PATHOLOGIES CAUSED BY INFILTRATION IN A LONG-STAY INSTITUTION FOR THE ELDERLY: A CASE STUDY

This paper is part of an extension project aimed at renovating the Carlos Romeiro Asylum, a long-stay institution for the elderly located in Conselheiro Lafaiete, Minas Gerais, starting from an initial conception about the current state of the building. For this, it was developed a literature review on the main cause of pathologies that affect the building, infiltration and humidity damage, and others. A case study will be presented, showing the main physical deficiencies of this resting house, to propose interventions based on Material Science and Civil Engineering. Because it is a place where the construction work must be done concomitantly with the circulation of people, this project needs to be divided into stages. It is important to point out that this work may involve both recovery materials and methods, which aim to reestablish the original conditions of the damaged structures, and reinforcement, which aim to adjust the resistant capacity of the structures according to their use. The development and application of this project will bring improvements to the elderly population of the

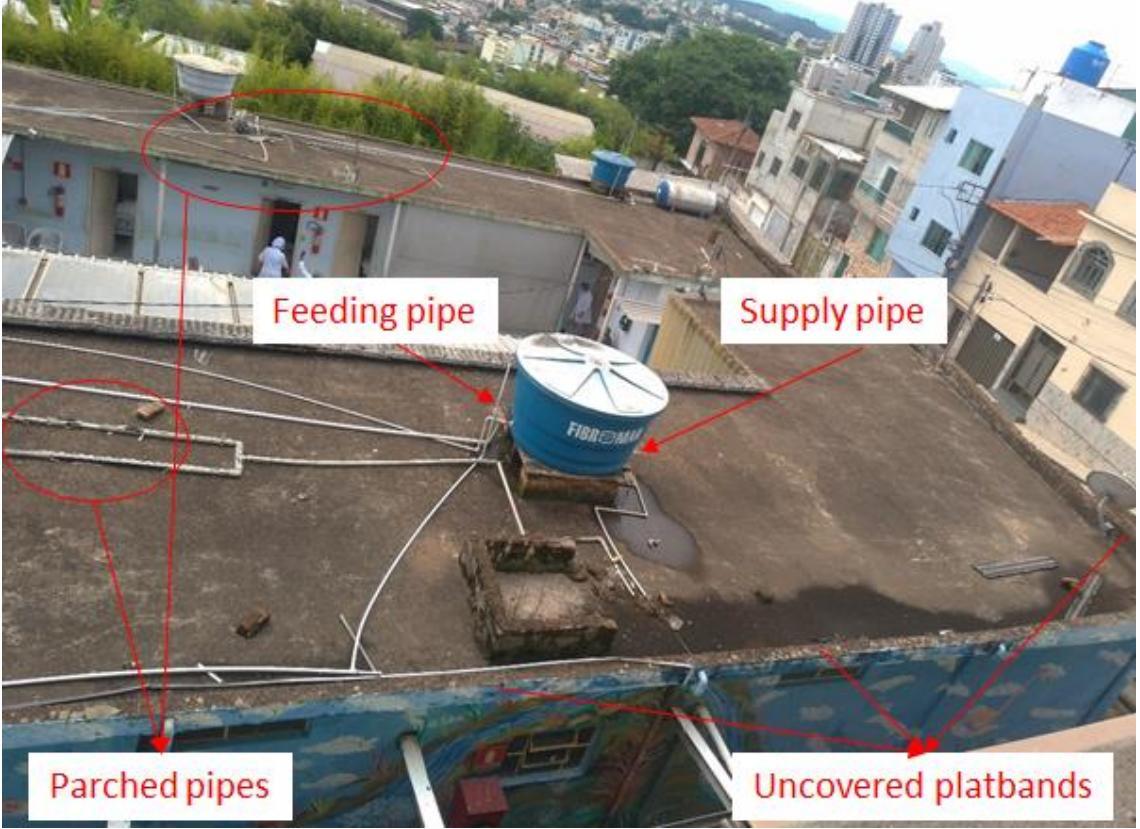
In November 2020, still at the beginning of the rainy season, the first technical visit to the nursing home was carried out, in which the need for emergency improvements in the structure of the building was verified. The occurrence of numerous pathologies was observed, the main ones being: infiltration through the floor, walls, and slabs; mold, padding, and peeling paint on the ceiling and walls; pathologies related to the movement of the structure, such as fissures, cracks, and cravices; broken, uneven and uneven floors; and poor air circulation in rooms and living areas.

Comparing Figure 1 with Figure 2, it can be seen that the wet regions are the same, even though the images were registered four months apart. In the March 2021 visit, a drip was detected on the water tank outlet pipe (supply), which points to a possible leak in the system, either directly in the tank material, which is visibly deformed, or in the pipe, connections, or special parts (valves, valves, etc.).

Another point to be observed is that, as the slab has no roof and, therefore, is directly exposed to the sun, the pipes are dry and increasing the system's losses, not serving its purpose, which is to supply the water outlets (taps, showers, etc.). In addition, it is not possible to identify in the photos the presence of the thief, necessary piping for situations in which the tap stops working, increasing the chances of a leak occurring. These leaks need to be verified in another inspection but may be responsible for the high values of the asylum's water bills, as reported by its administration.

Figure 1 – Uncovered slabs, in November 2020. Source: Developed by the authors

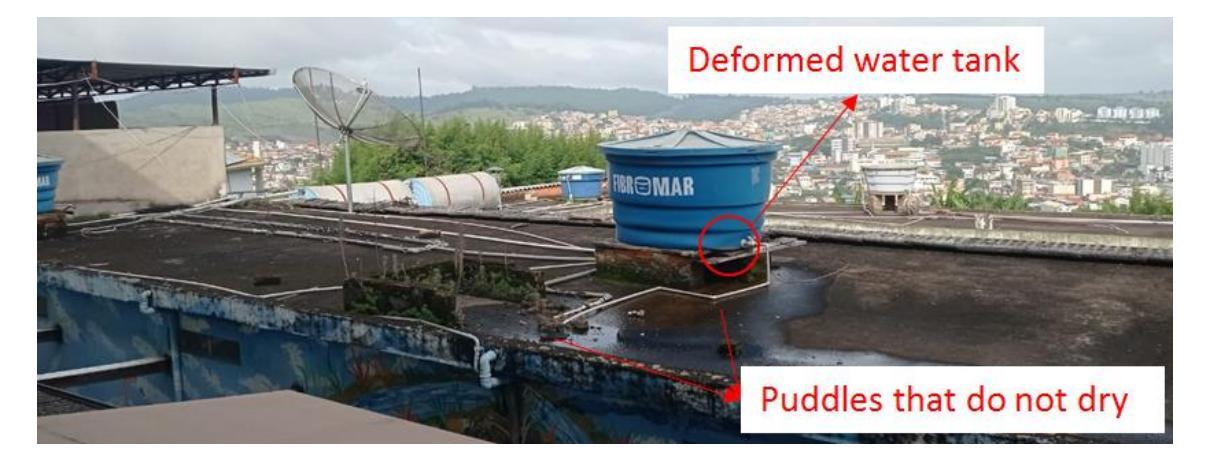
Figure 2 - Uncovered slab, in March 2021. Source: Developed by the authors

In addition, it can be seen from the above images that reinforced concrete slabs and exposed balconies are susceptible to water infiltration through the pores of the material, which leads to other negative consequences, as seen in the following images.

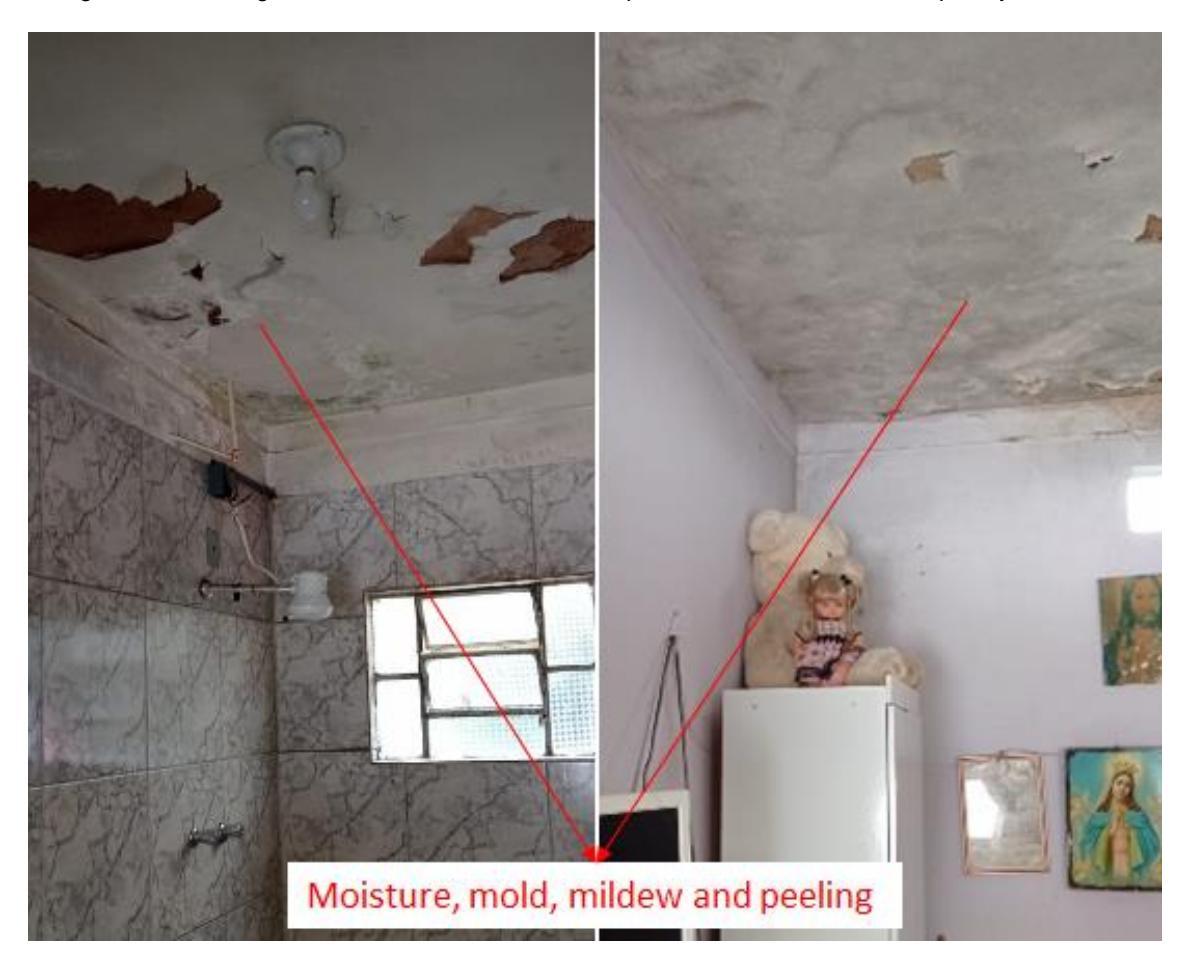
In Figure 3, besides the pathologies to be pointed out in the sequence of this document, the precarious conditions of the bathroom facilities are highlighted, which, although not so visible in the image, are recurrent in all of the building's facilities.

Figure 3 - Pathologies associated with moisture in exposed slabs. Source: Developed by the authors

Also in Figure 3, unpleasant and common occurrences are noted, especially in areas where moisture can enter from the outside or in parts of the building where there is excess moisture: mold, mildew, and peeling. Simply put, mold is caused by excess moisture, which in buildings can be caused by leaking pipes, increased moisture in basements or first floors, damage to the roof, walls, or around window frames.

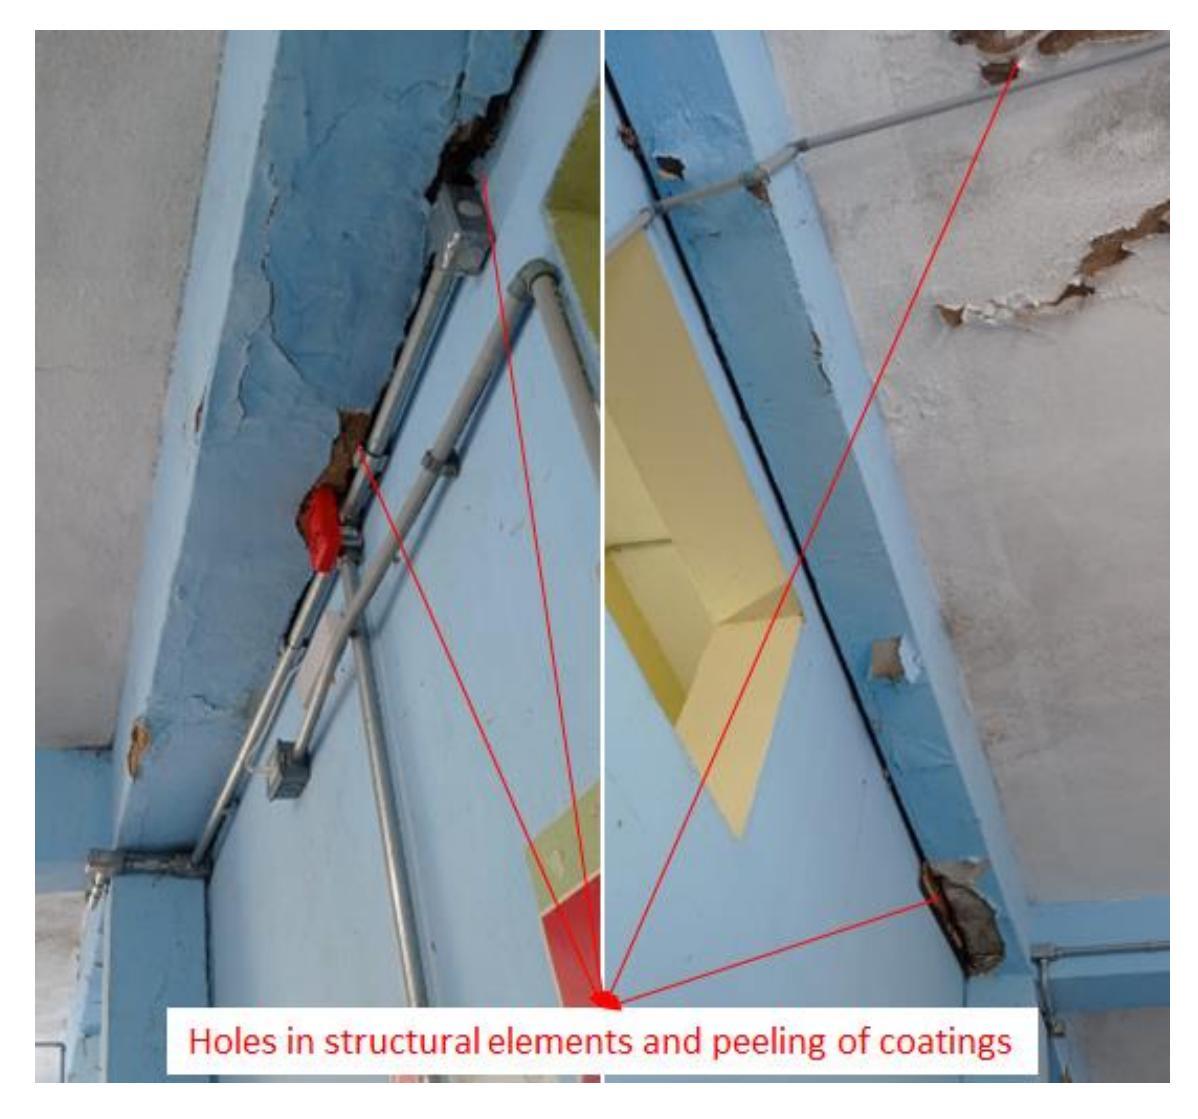
In Figure 4, as well as in the pictures presented previously, you can see the destruction of the paint, which crumbles and detaches from the surface along with parts of the plaster. In the construction phase, this problem occurs when the paint is applied before the plaster is cured; however, after years of use of the building, it is associated with excessive moisture in the structural and sealing elements.

Figure 4 – Holes in reinforced concrete beams for passage of conduits. Source: Developed by the authors

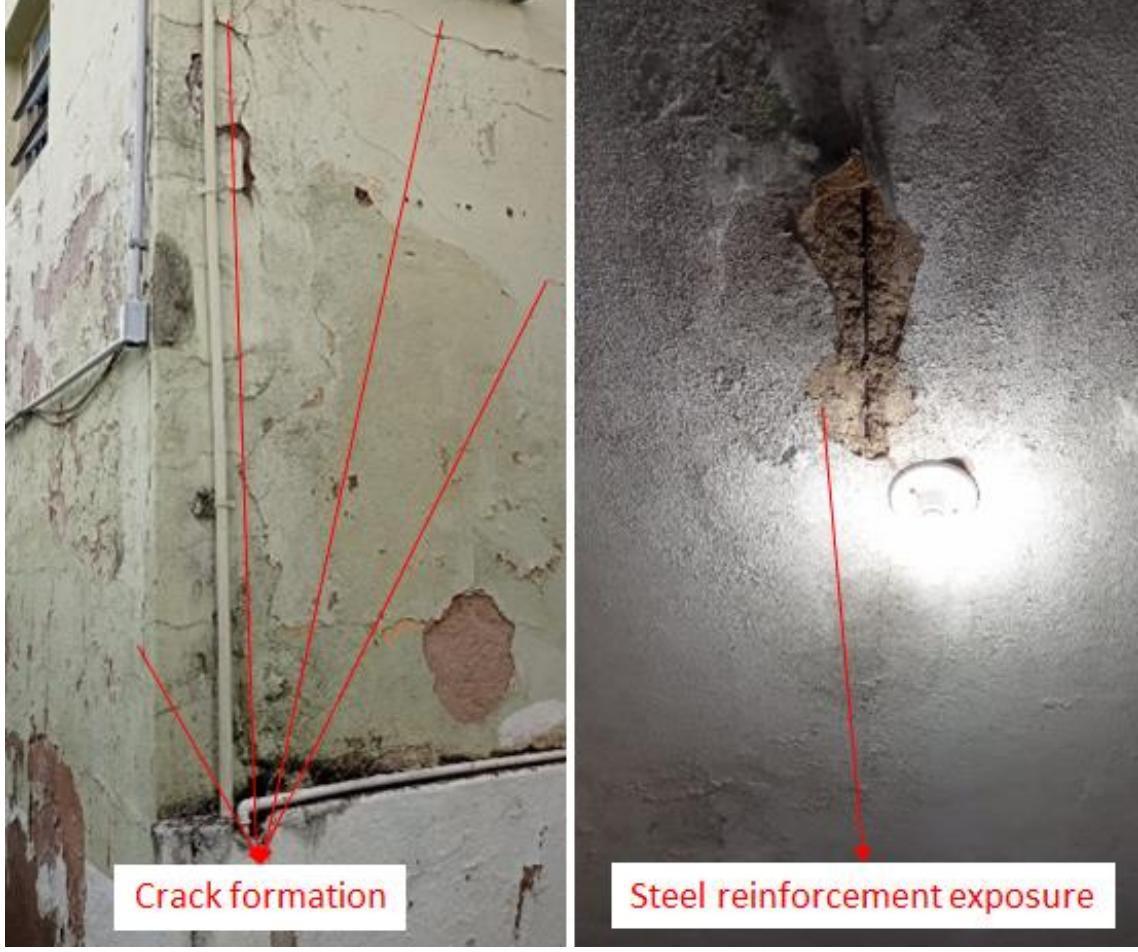
In this aspect, Figure 5 presents this characteristic pathological manifestation with high occurrence in reinforced concrete structures: cracking. The same figure also shows another recurring problem, the exposure, and corrosion of reinforcement.

Figure 5 – Reinforcement exposure and corrosion. **Source:** Developed by the authors

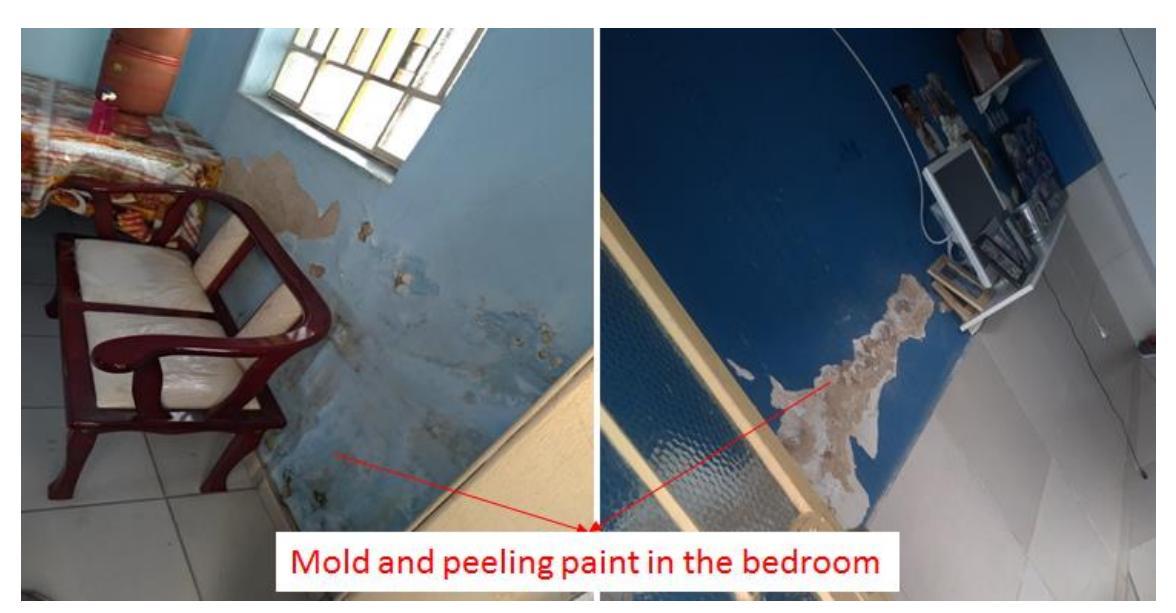
Figure 6 shows yet another pathology found in the facilities of the asylum, the exposure, and corrosion of reinforcement, which is closely related to the opening of cracks. This is a process of material deterioration through chemical and electrochemical oxidation reactions. In other words, the corrosion of steel is its transformation into rust.

In Figure 6, one can observe the occurrence of pathologies already presented, but with a different origin. This is moisture by capillarity, which rises from the ground and occurs in the foundations of buildings, due to soil conditions. When there are no obstacles, the humidity quickly advances in the walls. It also occurs due to materials that have capillary channels, such as ceramic blocks, concrete, mortar, among others.

Figure 6 – Molds and peeling from soil moisture. Source: Developed by the authors

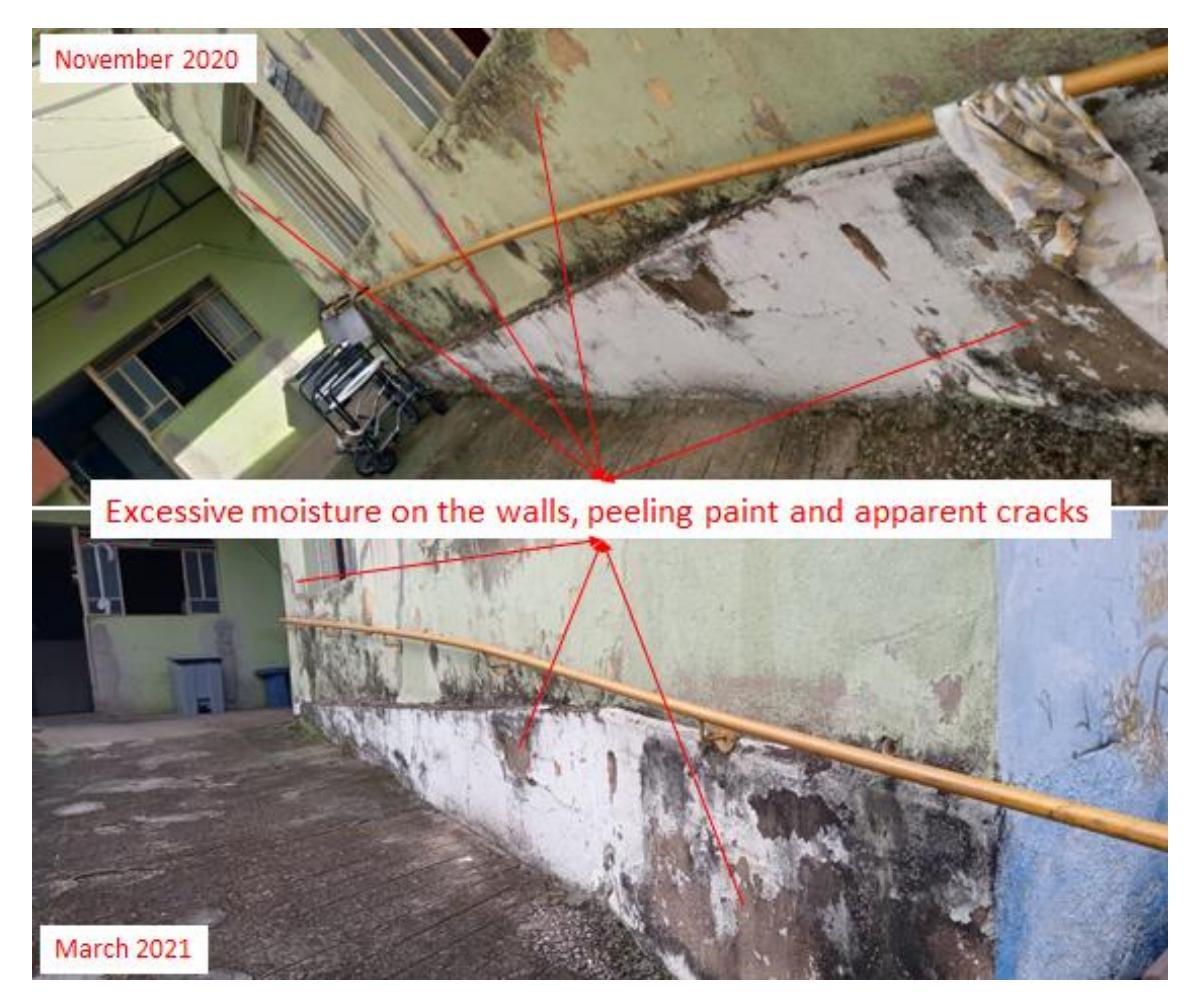
- Stains at the base of the buildings (observed in Figure 7);
- Destruction of coatings, due to the formation of sulfate;
- Formation of mold and mildew (seen in Figure 7);
- Increased heat dispersion from the inside of the building;
- · Cold masonry, where condensation phenomena are evident;
- Unhealthy environment;
- Peeling of the coatings due to salt crystallization (observed in Figure 7).

Figure 7 shows the pathologies described above, but now with an emphasis on the return that occurred within four months, precisely during the rainy season in the region. It is noteworthy that changes in the coatings can impair the performance and basic functions of the building, such as the aesthetic and economic value, the water tightness of the sealant, the regularization, and the finishing of the facade.

Figure 7 – Critical state and in the progressive stage of the building's front façade. **Source:** Developed by the authors

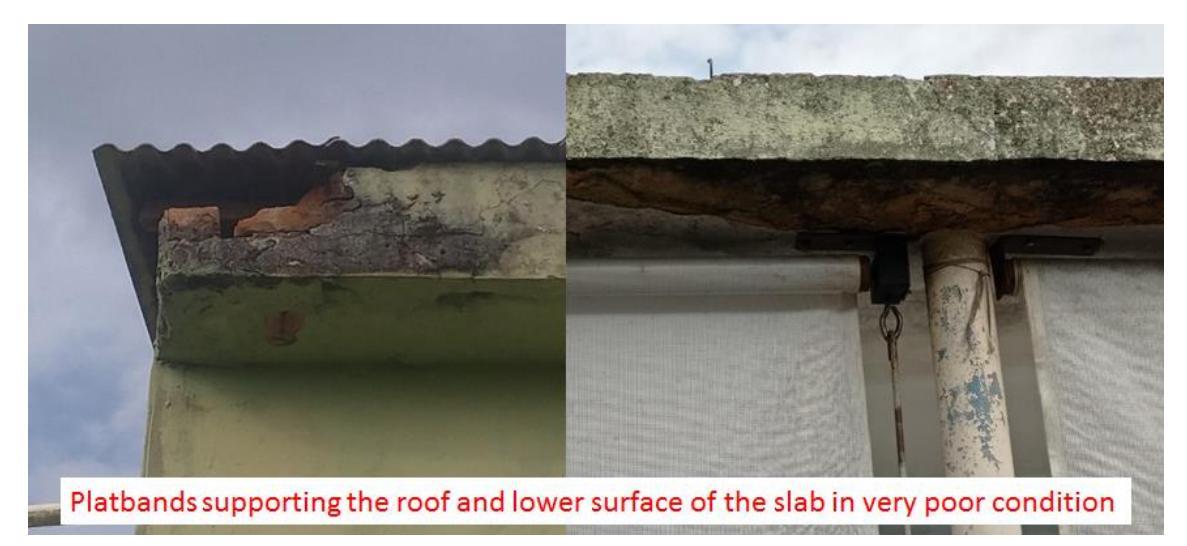
Figure 8 and Figure 9 show the very poor conditions of the roofs of the external area, in which it is possible to see several foci of leaks.

Roofs with leaks and irregularities

Figure 8 - Irregularities in the coverage of the outdoor area. Source: Authors

Figure 9 – Pathologies on the platbands and the underside of the slab in the external area. Source: Developed by the authors
