PATHOLOGIES CAUSED BY INFILTRATION IN A LONG-STAY INSTITUTION FOR THE ELDERLY: A CASE STUDY

This paper is part of an extension project aimed at renovating the Carlos Romeiro Asylum, a long-stay institution for the elderly located in Conselheiro Lafaiete, Minas Gerais, starting from an initial conception about the current state of the building. For this, it was developed a literature review on the main cause of pathologies that affect the building, infiltration and humidity damage, and others. A case study will be presented, showing the main physical deficiencies of this resting house, to propose interventions based on Material Science and Civil Engineering. Because it is a place where the construction work must be done concomitantly with the circulation of people, this project needs to be divided into stages. It is important to point out that this work may involve both recovery materials and methods, which aim to reestablish the original conditions of the damaged structures, and reinforcement, which aim to adjust the resistant capacity of the structures according to their use. The development and application of this project will bring improvements to the elderly population of the

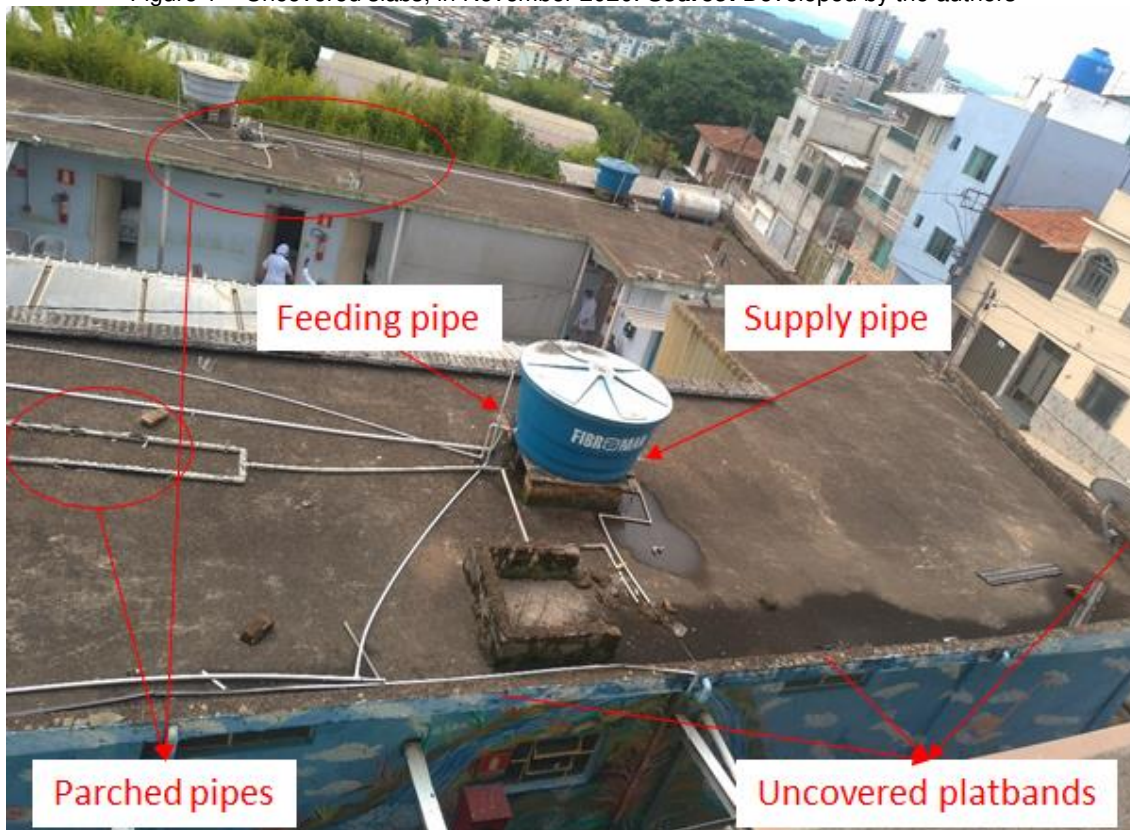
It is important to point out that these inspections were initial, aiming to get to know the conditions of the shelter better and to structure a project conception for its renovation. Some pathologies not identified in the first visit were verified in the second, such as leaking pipes in the slab, insufficient drainage, disconnected gutters, differential ground settlement in the external area, irregular doors and frames, among others. All these problems can be seen in Figures 1 and 2.

Figure 1 – Uncovered slabs, in November 2020. **Source:** Developed by the authors

Comparing Figure 1 with Figure 2, it can be seen that the wet regions are the same, even though the images were registered four months apart. In the March 2021 visit, a drip was detected on the water tank outlet pipe (supply), which points to a possible leak in the system, either directly in the tank material, which is visibly deformed, or in the pipe, connections, or special parts (valves, valves, etc.).

Another point to be observed is that, as the slab has no roof and, therefore, is directly exposed to the sun, the pipes are dry and increasing the system's losses, not serving its purpose, which is to supply the water outlets (taps, showers, etc.). In addition, it is not possible to identify in the photos the presence of the thief, necessary piping for situations in which the tap stops working, increasing the chances of a leak occurring. These leaks need to be verified in another inspection but may be responsible for the high values of the asylum's water bills, as reported by its administration.

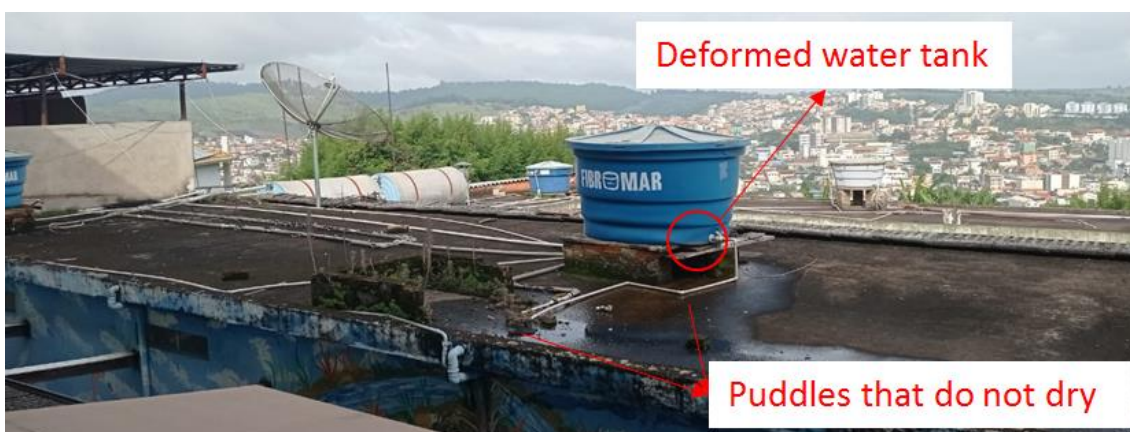
Figure 2 – Uncovered slab, in March 2021. **Source:** Developed by the authors

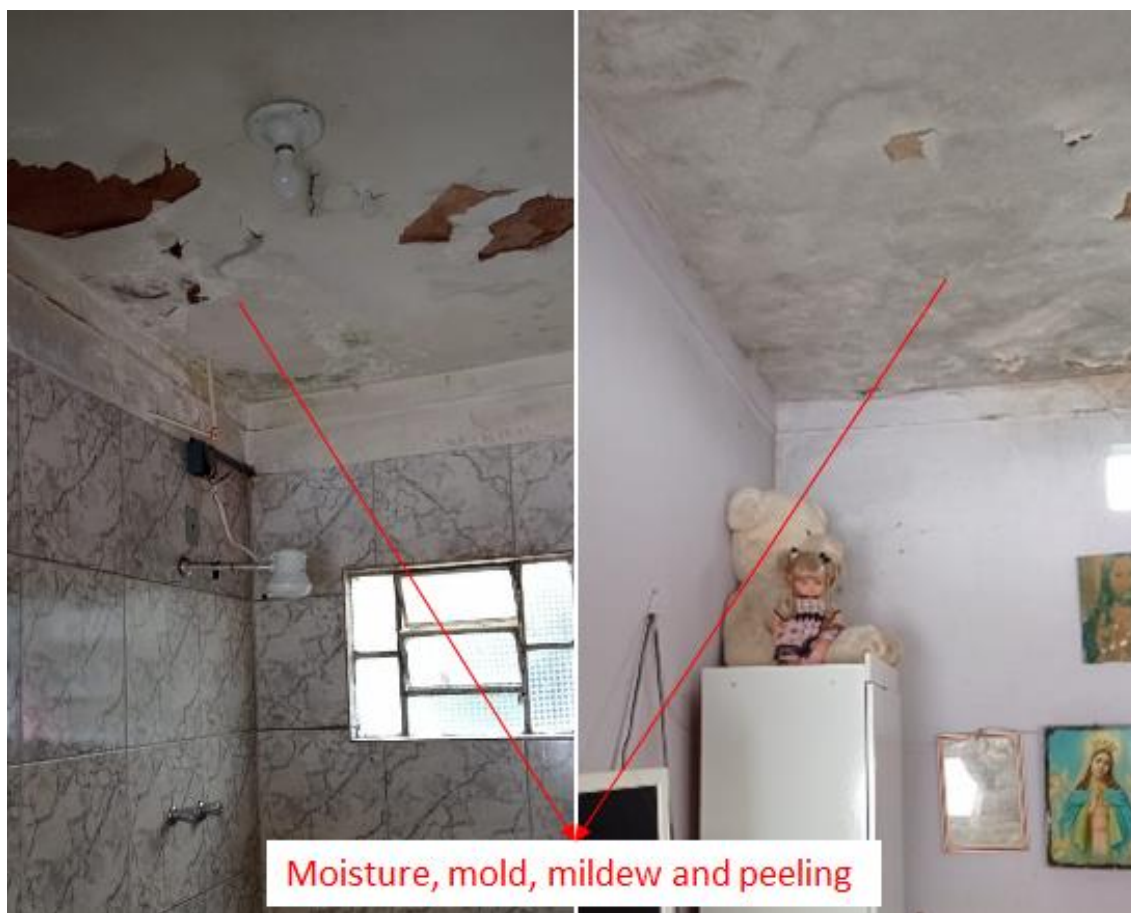
In Figure 3, besides the pathologies to be pointed out in the sequence of this document, the precarious conditions of the bathroom facilities are highlighted, which, although not so visible in the image, are recurrent in all of the building's facilities.

Figure 3 – Pathologies associated with moisture in exposed slabs. **Source:** Developed by the authors

Also in Figure 3, unpleasant and common occurrences are noted, especially in areas where moisture can enter from the outside or in parts of the building where there is excess moisture: mold, mildew, and peeling. Simply put, mold is caused by excess moisture, which in buildings can be caused by leaking pipes, increased moisture in basements or first floors, damage to the roof, walls, or around window frames.

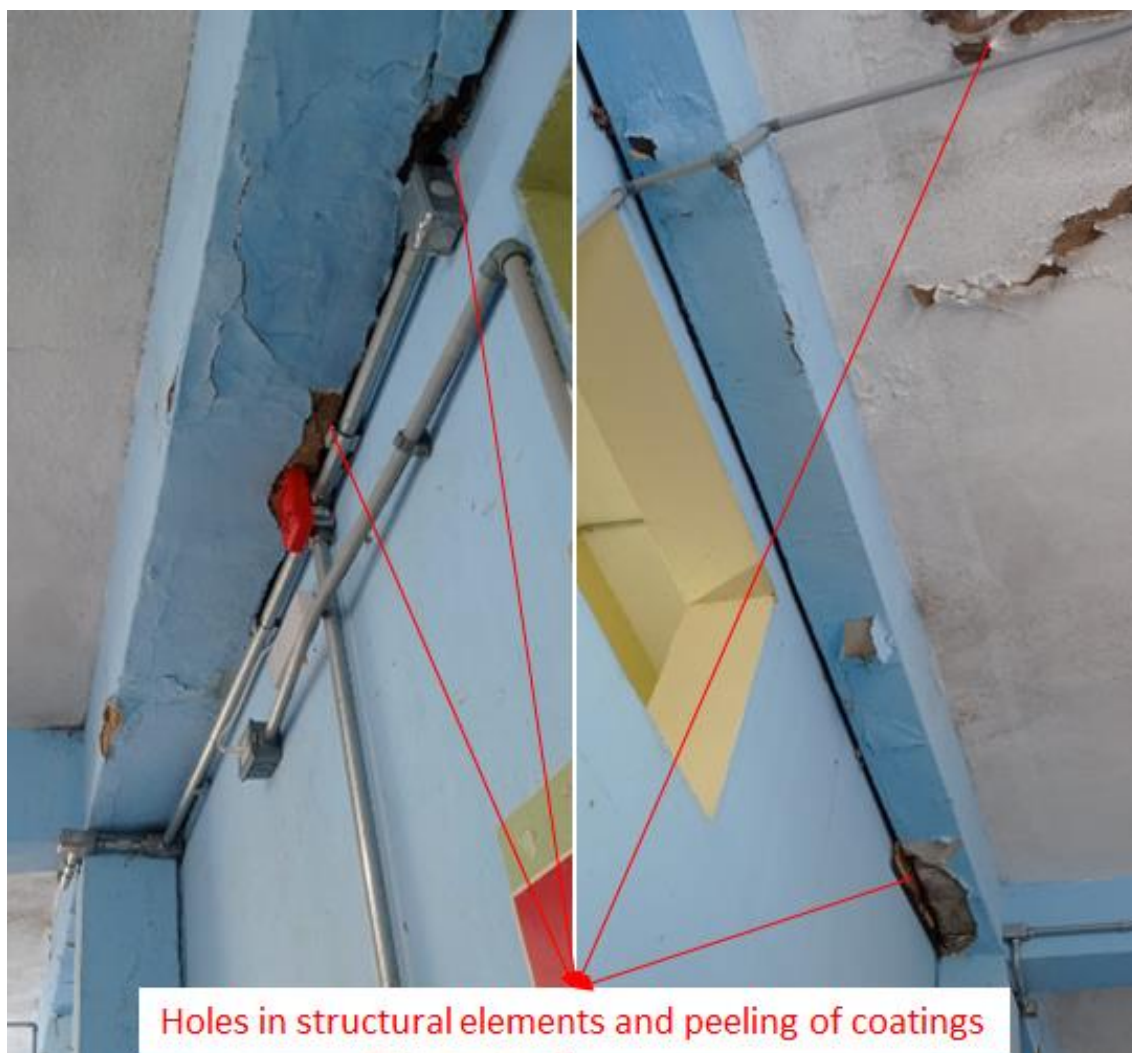
In Figure 4, as well as in the pictures presented previously, you can see the destruction of the paint, which crumbles and detaches from the surface along with parts of the plaster. In the construction phase, this problem occurs when the paint is applied before the plaster is cured; however, after years of use of the building, it is associated with excessive moisture in the structural and sealing elements.

Figure 4 – Holes in reinforced concrete beams for passage of conduits. **Source:** Developed by the authors

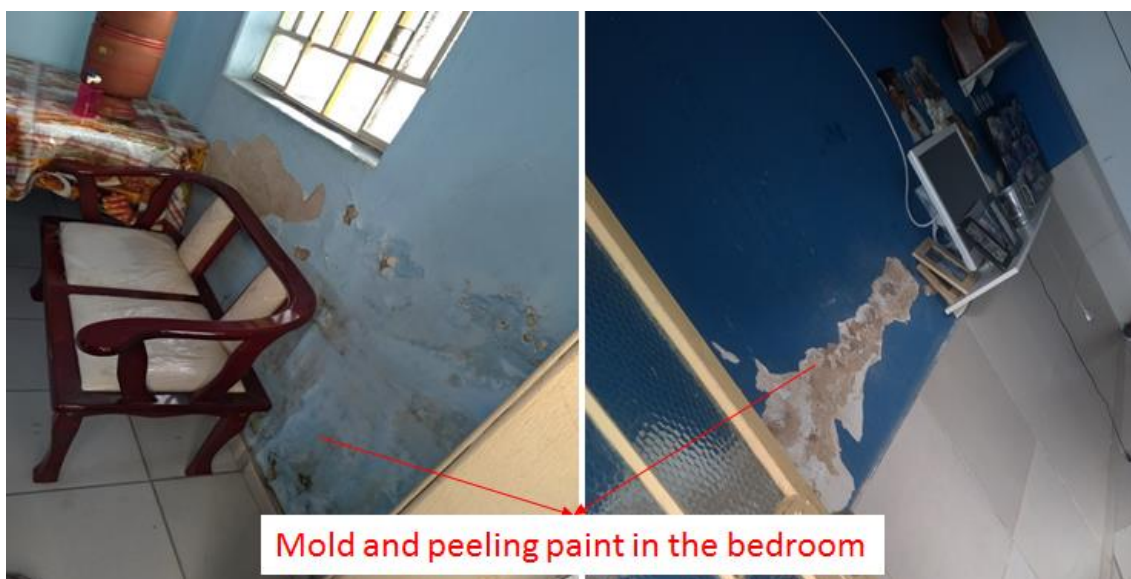
In Figure 6, one can observe the occurrence of pathologies already presented, but with a different origin. This is moisture by capillarity, which rises from the ground and occurs in the foundations of buildings, due to soil conditions. When there are no obstacles, the humidity quickly advances in the walls. It also occurs due to materials that have capillary channels, such as ceramic blocks, concrete, mortar, among others.

Figure 6 – Molds and peeling from soil moisture. **Source:** Developed by the authors

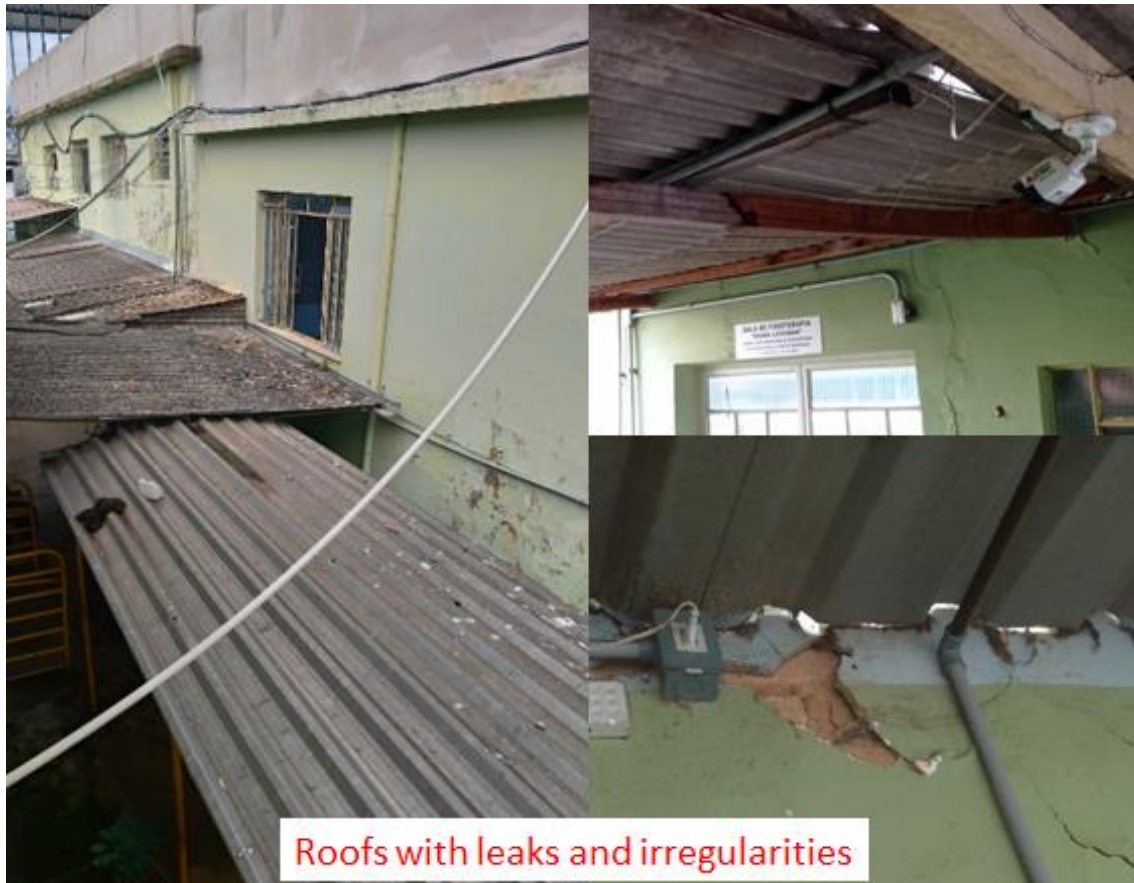
Figure 8 and Figure 9 show the very poor conditions of the roofs of the external area, in which it is possible to see several foci of leaks.

Figure 8 – Irregularities in the coverage of the outdoor area. Source: Authors

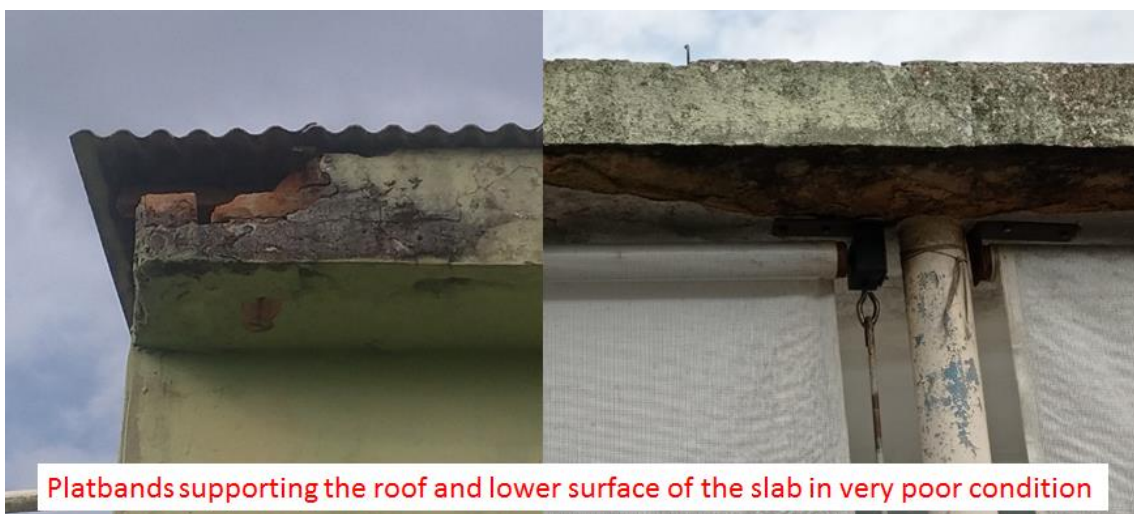
Figure 9 – Pathologies on the platbands and the underside of the slab in the external area. **Source:** Developed by the authors
