PATHOLOGIES CAUSED BY INFILTRATION IN A LONG-STAY INSTITUTION FOR THE ELDERLY: A CASE STUDY

This paper is part of an extension project aimed at renovating the Carlos Romeiro Asylum, a long-stay institution for the elderly located in Conselheiro Lafaiete, Minas Gerais, starting from an initial conception about the current state of the building. For this, it was developed a literature review on the main cause of pathologies that affect the building, infiltration and humidity damage, and others. A case study will be presented, showing the main physical deficiencies of this resting house, to propose interventions based on Material Science and Civil Engineering. Because it is a place where the construction work must be done concomitantly with the circulation of people, this project needs to be divided into stages. It is important to point out that this work may involve both recovery materials and methods, which aim to reestablish the original conditions of the damaged structures, and reinforcement, which aim to adjust the resistant capacity of the structures according to their use. The development and application of this project will bring improvements to the elderly population of the

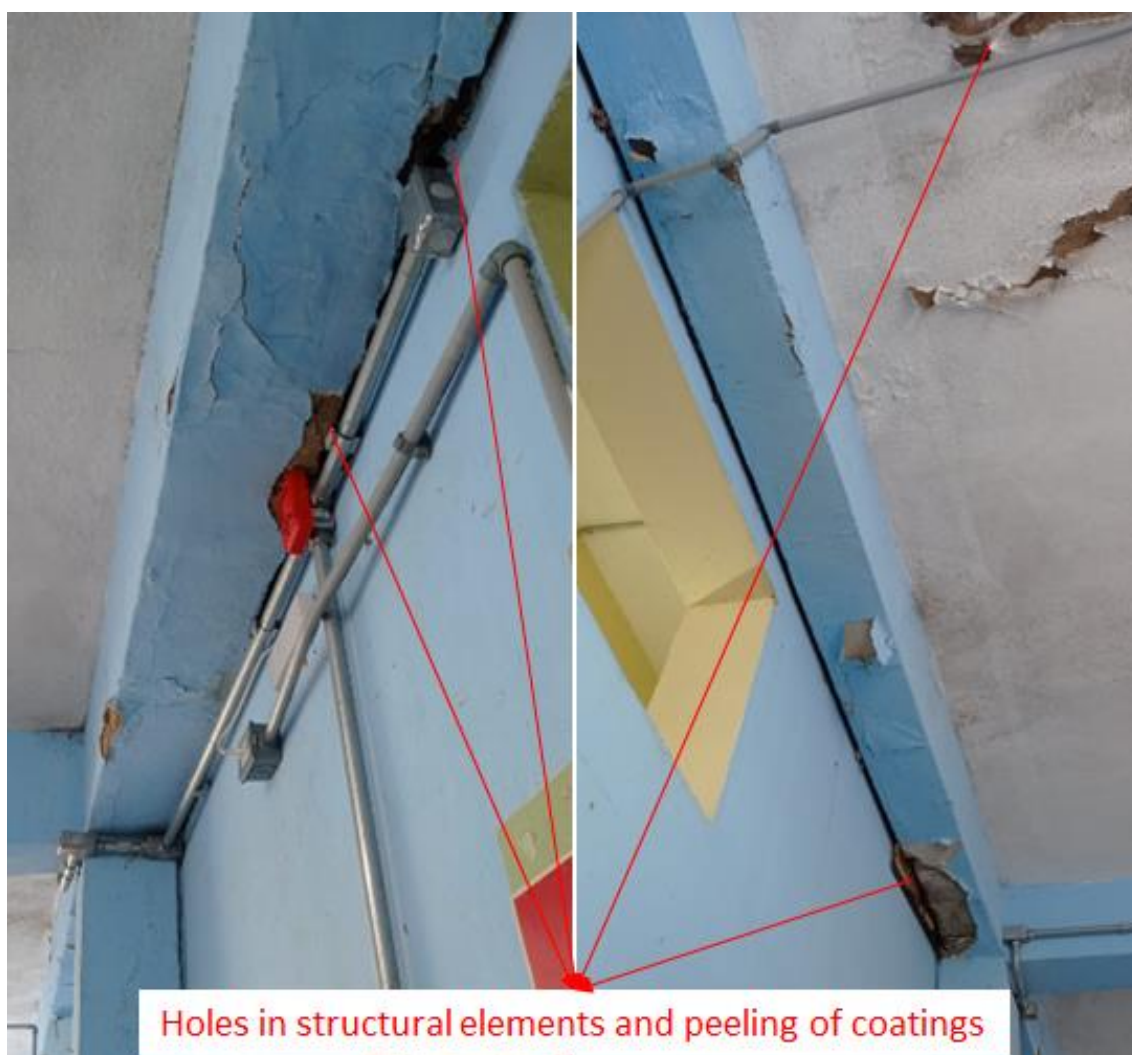
In Figure 4, as well as in the pictures presented previously, you can see the destruction of the paint, which crumbles and detaches from the surface along with parts of the plaster. In the construction phase, this problem occurs when the paint is applied before the plaster is cured; however, after years of use of the building, it is associated with excessive moisture in the structural and sealing elements.

Figure 4 – Holes in reinforced concrete beams for passage of conduits. **Source:** Developed by the authors

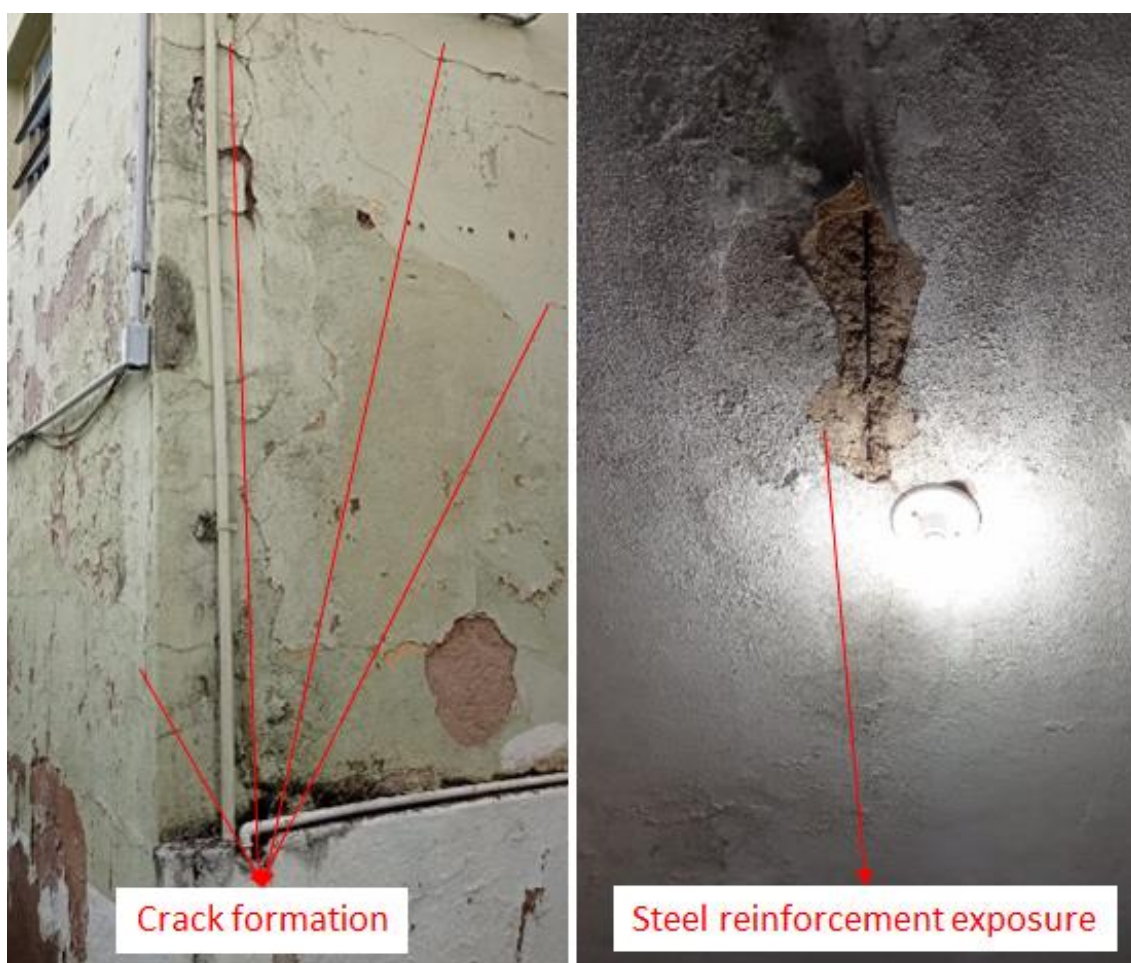
In this aspect, Figure 5 presents this characteristic pathological manifestation with high occurrence in reinforced concrete structures: cracking. The same figure also shows another recurring problem, the exposure, and corrosion of reinforcement.

Figure 5 – Reinforcement exposure and corrosion. **Source:** Developed by the authors

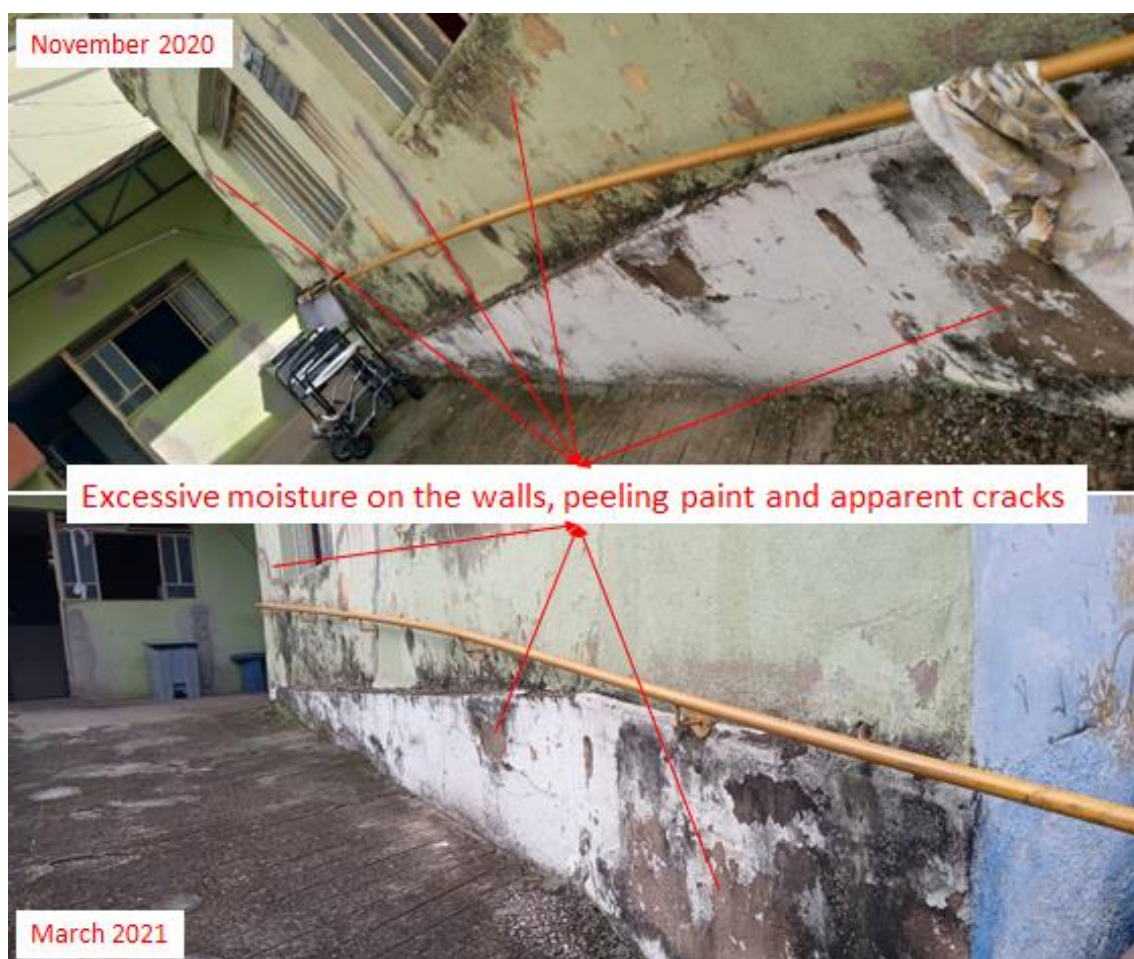
- Stains at the base of the buildings (observed in Figure 7);
- Destruction of coatings, due to the formation of sulfate;
- Formation of mold and mildew (seen in Figure 7);
- Increased heat dispersion from the inside of the building;
- Cold masonry, where condensation phenomena are evident;
- Unhealthy environment;
- Peeling of the coatings due to salt crystallization (observed in Figure 7).

Figure 7 shows the pathologies described above, but now with an emphasis on the return that occurred within four months, precisely during the rainy season in the region. It is noteworthy that changes in the coatings can impair the performance and basic functions of the building, such as the aesthetic and economic value, the water tightness of the sealant, the regularization, and the finishing of the facade.

Figure 7 – Critical state and in the progressive stage of the building's front façade. **Source:** Developed by the authors

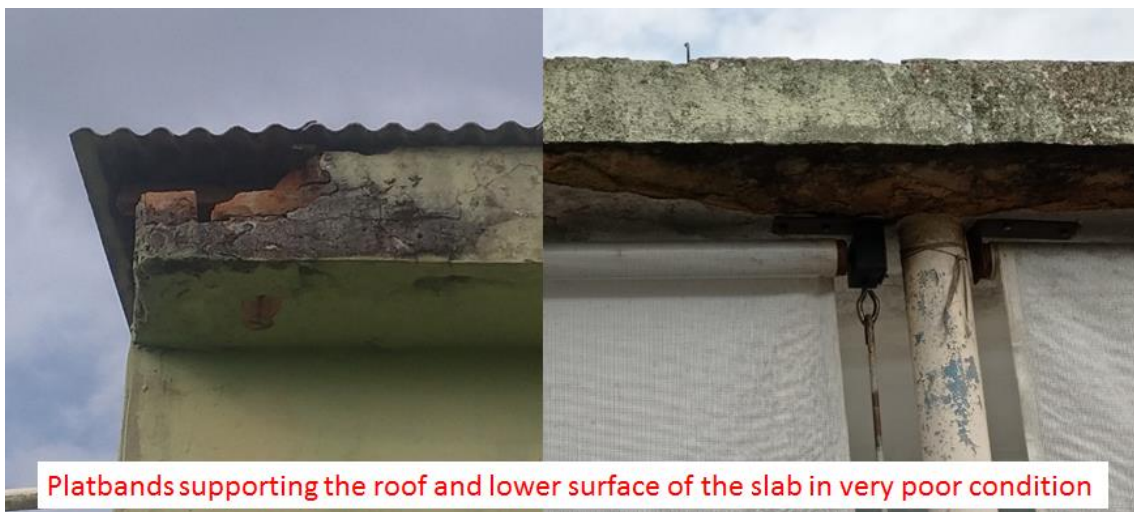
Figure 8 and Figure 9 show the very poor conditions of the roofs of the external area, in which it is possible to see several foci of leaks.

Figure 9 – Pathologies on the platbands and the underside of the slab in the external area. **Source:** Developed by the authors
