AESTHETIC AND FUNCTIONAL REHABILITATION BY ASSOCIATING INJECTION-MOLDED, IMMEDIATE-LOADED, TWO-PIECE ZIRCONIA IMPLANTS AND CERAMIC VENEERS

Paola Rebelatto Alcântara¹, Geninho Thomé², Camila Pereira Vianna³, Roberta Schroder Rocha⁴, Waleska Furquim⁵, Rubens Moreno de Freitas⁶

https://doi.org/10.47820/recima21.v5i2.4448

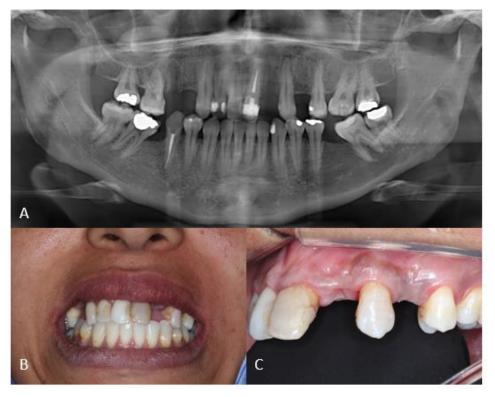
Figure 1. Panoramic radiographic of patient's initial condition (A). Extraoral frontal view of patient's initial aspect (B). Intraoral lateral view evidencing the absence of elements #22 and #24 (C).

A 36-year-old female patient, in good general health, was referred to llapeo College due to the absence of dental elements 22 and 24. She reported dissatisfaction with her smile, not only due to the absence of these elements, but also due to the presence of an anterior dental element with color alteration by endodontic treatment, deviated upper midline, projection of anterior teeth, and stained anterior restorations (Figure 1A-C). After clinical and radiographic evaluation, and considering that the esthetics were the main complaint, it was decided to perform a prosthetic rehabilitation of the maxilla, including implant-supported prosthesis with zirconia implants. Written consent was given by the patient.

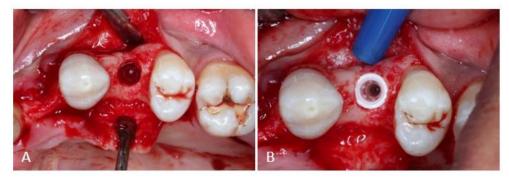
Figure 2. Occlusal view of bone bed preparation (A) and two-piece zirconia implant bone level final position in region #24 (B).

The same surgical and prosthetic protocol was applied for both implants, in regions #22 and #24. After local anesthesia and incision, a small flap was raised. The site preparation sequence was performed as recommended by the manufacturer and with adequate irrigation. Two-piece injection-molded yttria-stabilized zirconia implants (Zirconia Implant, Neodent) were placed in regions 22 (3.75x13mm) and 24 (4.3x13mm) (Figure 2A-B) reaching final installation torque of 45N.cm, which allowed immediate provisionalization. Peek Abutments (Neodent) (Figure 3A) were then selected and installed to support the provisional acrylic resin prostheses (Figure 3B). Sutures were placed to close the surgical wound and removed 10 days later. Periapical radiographs were obtained to verify the correct positioning of the implants (Figure 3C).

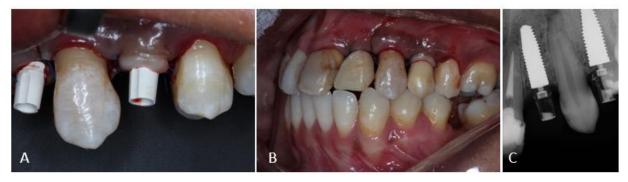
Figure 3. Lateral view of Peek abutments (A). Clinical (B) and radiographic (C) aspects of immediate provisionalization.

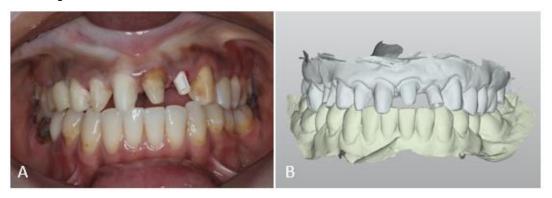
Figure 7. Frontal view of prepared anterior elements and Peek CR in region #22 (A). Intraoral scanning image for restoration confection (B).

Next, preparations were made using the silicone guides obtained after the diagnostic wax-up (Figure 7A). The patient was then submitted to a new intraoral scan with the appropriate scanbodies in

position (Figure 7B) and provisional crowns were made in bisacrylic resin Protemp (3M) over all the elements being treated.

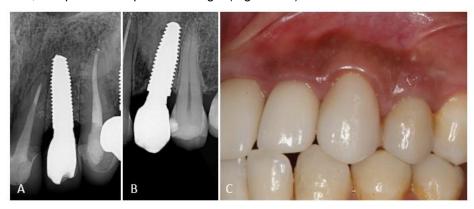
Figure 9. Radiographic (A-B) and clinical (C) aspects after two years of follow-up. Bone level maintenance great soft tissue esthetics were observed.

implants and the aesthetic and functional rehabilitation of the anterior maxilla showed clinical and radiographic success. Implants presented complete osseointegration and stability, absence of signs of peri-implantitis, and good maintenance of the marginal bone level (Figure 9A-B). Also, excellent soft tissue esthetics were observed, presenting a harmonious shape of the interdental papillae, inserted gingival appearance, and precise shape of its margin (Figure 9 C).
